# insider info

## ISC Valve Cleaning

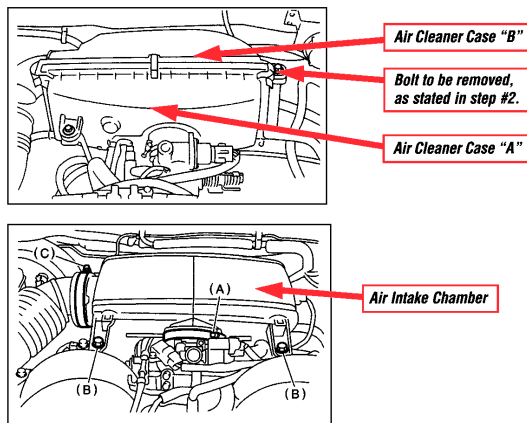
## Normally Aspirated Engine ISC Cleaning Procedure

If you encounter a driveability concern such as idle surges or whistling, it may be caused by carbon buildup on the idle speed control (ISC) valve. In these cases, it is not necessary to replace the ISC valve. Cleaning the ISC valve could correct the condition. To clean an ISC valve, perform the following procedure.

1. Warm up the engine.
2. On 2.2 and 2.5L engines only, remove the bolt that attaches the air cleaner case "B" to the bracket. Undo the three clips that hold air cleaner case "B" to air cleaner case "A." Remove the air cleaner case "B" and the air cleaner element and set them aside. (On all 3.0L H6, remove the entire air intake chamber).

3. Start the engine and maintain 1000-1500 rpm.
4. Spray engine cleaner GM Top Engine Cleaner (Part #12345089) or equivalent toward the upper air-stream of the throttle chamber for approximately 10 seconds.

5. Stop the engine and let it sit for three minutes.
6. Restart the engine and maintain 1000-1500 rpm.
7. Spray engine cleaner on the upper air-stream of the throttle chamber for approximately 10 seconds.

8. Turn the engine off.
9. Reinstall the air cleaner element and air cleaner case "B."
10. Operate the engine between 1000-2000 rpm until no white smoke appears from the tailpipe.

11. Turn the ignition switch OFF and clear memory.
