insider info.

Replacing AWD Rear Wheel Bearings on Legacy, Impreza and SVX

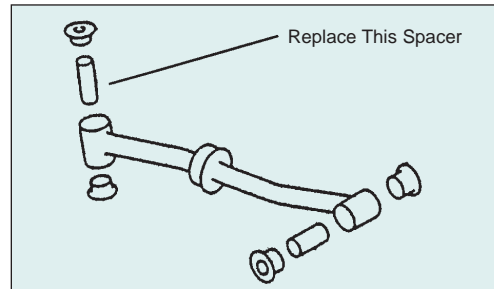
1996 Legacy Spacer

If you encounter a shifter rattle complaint on a 1996/97 Legacy Outback or on a 1998 Forester, the necessary parts are available to correct this symptom.

For the 1996 Legacy Outback, order a modified spacer, P/N 35045AC040.
