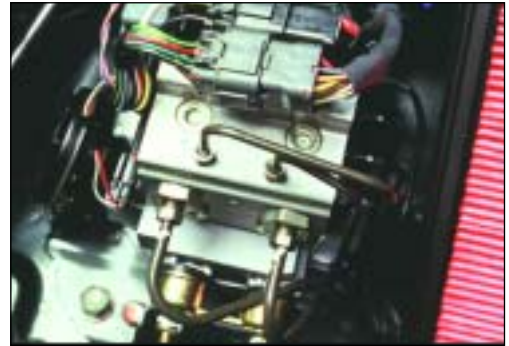
The ABS/TCS system was used on 1995 front wheel drive Legacy automatics with traction control and for that year only. The hydraulic unit has two brake lines coming in the top and two in the side. This system does communicate with the Select Monitor and it has a long-term memory. The computer is under the passenger's seat.

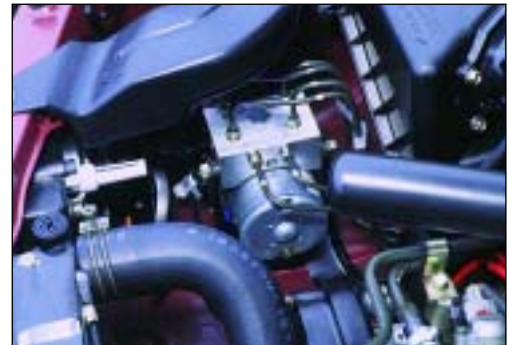
The ABS 5.3 system has the motor for the hydraulic unit sticking straight up with two brake lines going in the top of the unit and four out the side. This system does communicate with the Select Monitor. The computer is to the right of

the glove box in Legacy vehicles and to the left of the steering column in Impreza vehicles.

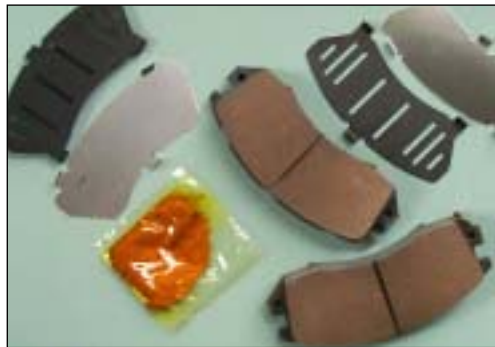
Brake Grease with Shims

A special grease, P/N K0777YA010, is available for brake judder and noise complaints. The grease has good durability against heat and water when compared to PBC grease. It should be applied between the brake pad and the shim. The grease has been added production and is included in genuine Subaru brake pad kits.

1. Use an "on the car" type brake lathe to cut the rotors and adjust lateral run-out of the machine to less than .002 inch.
2. Don't replace or cut the rotor in case of a brake noise condition. Replace the brake pads and apply the new brake grease between the brake pad and shim only.
