# insider info

## ISC Valve Cleaning

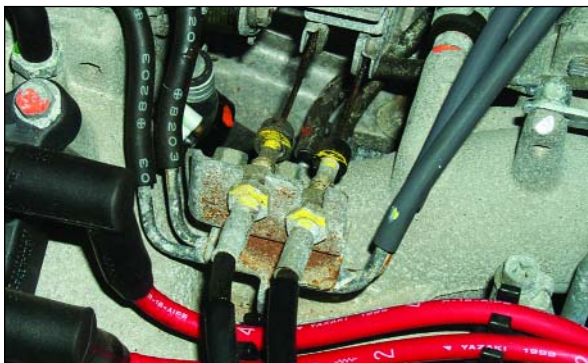
### DTC P0507 - Idle Control System RPM Higher Than Expected

If you find yourself diagnosing a DTC P0507 — Idle Control System RPM higher than expected — check to see if the accelerator or cruise control cables are adjusted properly.

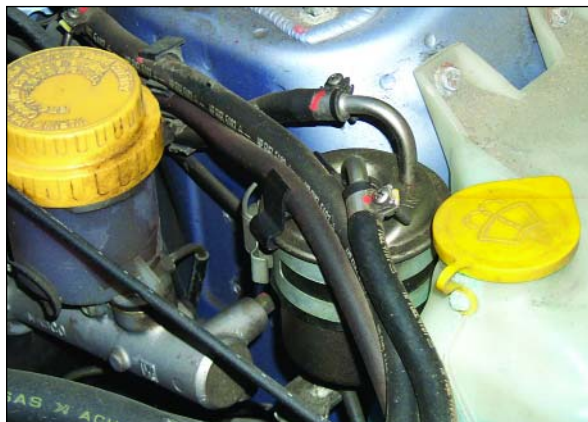
If you encounter cylinder misfire codes on Subaru vehicles equipped with the OBD II system, check the past service history to see if the vehicle's fuel filter was recently changed.

There is a short period of time when the vehicle is first started, after the filter has been changed, when the cylinders may not get the fuel charge they should. This may translate into a slight cylinders misfire, which is enough to trigger a misfire DTC.

If the fuel filter was changed recently, clear the codes and test drive the vehicle. Chances are good that the codes will not return if the filter change was the cause of the problem.
