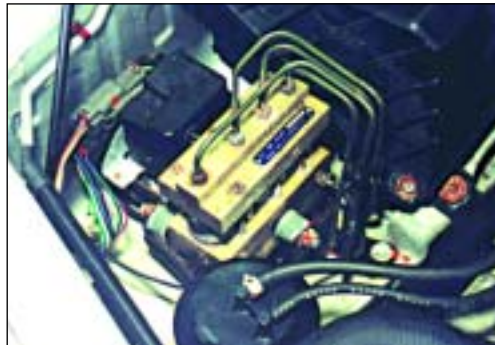
The Nippon system has the brake lines coming into the top of the unit and is distinctive due to the fact that it has brake bleeder nipples on the top of the hydraulic unit cylinder head. The Bosch system looks very similar to the Nippon, with the brake lines coming in the top of the unit, but the lines are in a more square pattern and there are no brake bleeders on the cylinder head. Both of these systems have no long-term memory (once you turn the key off, all codes are erased from memory) and can display only one diagnostic code at a time from the LED on the computer under the passenger's seat.
